External Water-Bar Installation – National Starch, Karasin

Whether damaged during installation, incorrectly detailed or omitted all together, the failure of the waterproofing at the main construction joint between two primary waste water treatment tanks caused major problems for National Starch maintenance staff in Karasin.

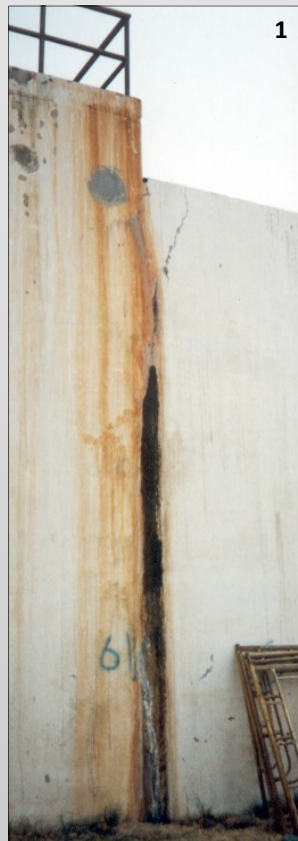
- 1 Failed construction joint
- 2 First pass PU injection
- 3 Forming chase
- 4 Second Pass PU injection
- 5 Installation
- 6 Surface repair
