## MRTA Initial System Project – Underground Structures North

### In-situ Repairs To Tunnel Segments

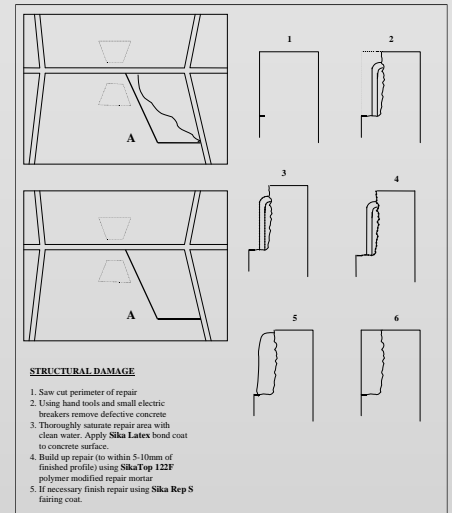
#### A. Structural Damage

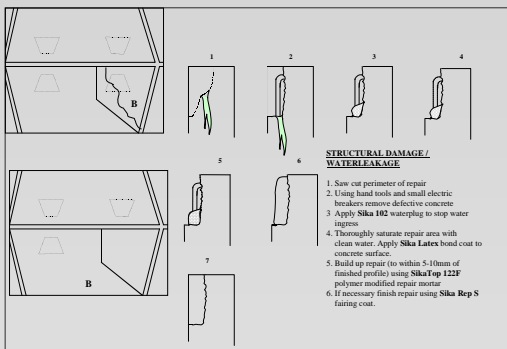
#### B. Structural Damage / Water Leak

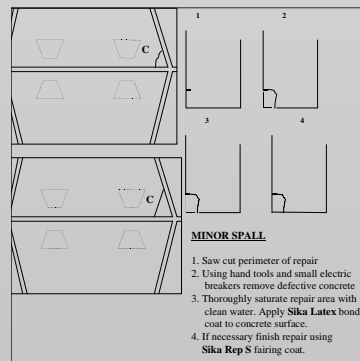
#### C. Minor Spall

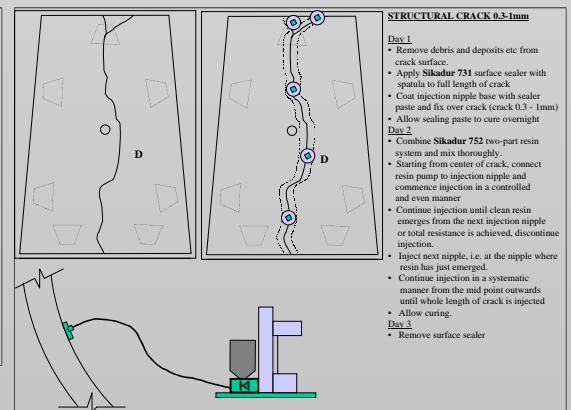
#### D. Structural Crack

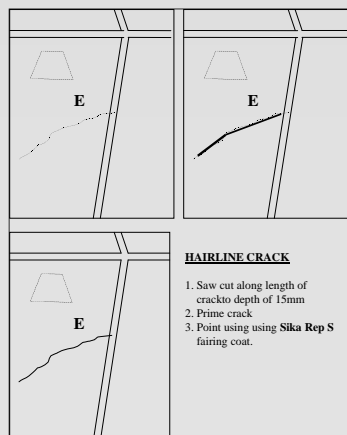
#### E. Minor Crack

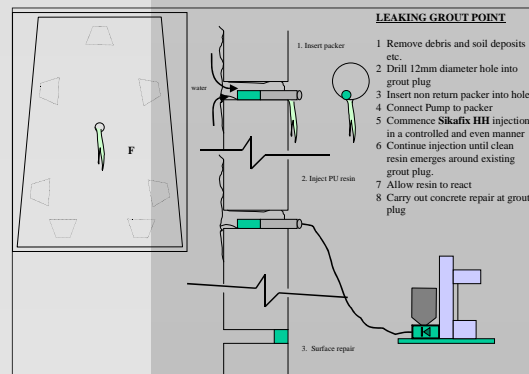
#### F. Leakage at Grout Point

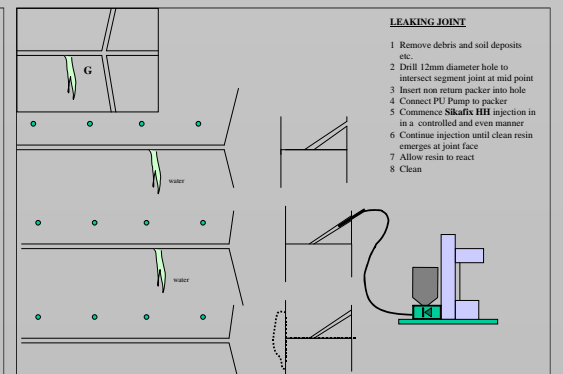
#### G. Leakage at Segment Joint
