RTGC Turning Plate Repairs – Laem Chabang Port

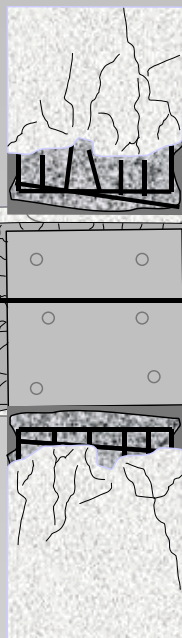
Repair type A – EXISTING REPAIR FAILURE

1. Continued cracking and spalling of concrete surface due to low strength concrete
2. Probable Water pockets under plate and grout
3. Weld failure due to plate movement
4. Failed Grout
5. Dowel grout failure / dowel weld failure

1. Remove steel plate and dowels
2. Saw cut perimeter of repair
3. Break out existing Concrete to a depth of app 200mm
4. Repair existing re-bar
5. Drill and fix dowels
6. Fix "L" dowels to main Steel
7. Saturate, prime and recast base concrete with modified non shrink grout
8. FIX 50X50mm mesh to "L" dowels
9. Pour Densitop grout "pad"
10. Place pre-drilled steel plate over dowels and level
11. Allow initial cure and clean out weld holes
12. Complete repair with Modified Densitop LT
13. Cure with sand and polythene sheet
14. Trim and re-weld dowels

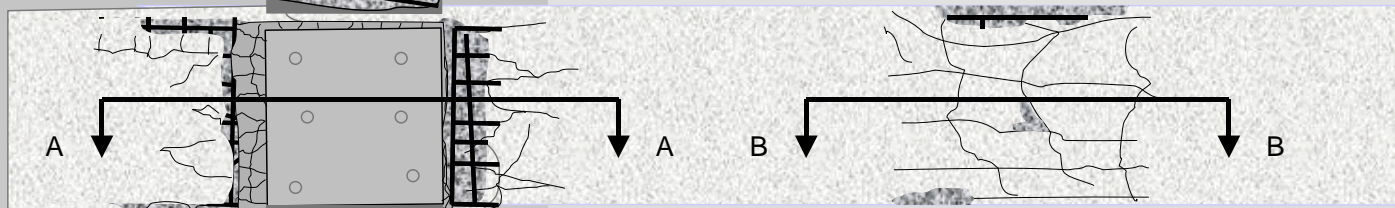
Repair type B – GENERAL SURFACE REPAIR

1. Continued cracking and spalling of concrete surface due to low strength concrete
2. Failed existing surface repair
3. Surface spalling and delamination

1. Saw cut perimeter of repair
2. Break out existing Concrete to a depth of app 50mm
3. Fill "low" areas with Densitop Filling Mortar
4. Drill and fix or weld "L" dowels
5. Fix 50mm x 50mm mesh to "L" dowels
6. Apply 30mm modified Densitop LT topping
7. Cure with sand and polythene sheet
