## DEBONDED RENDER REPAIR - ROYAL ORCHID SHERATON HOTEL

Following a full visual and “hammer tap” survey of the entire 32,000m<sup>2</sup> external facade of the Hotel, emergency repairs were carried out where it was deemed there was a real risk of render failure.

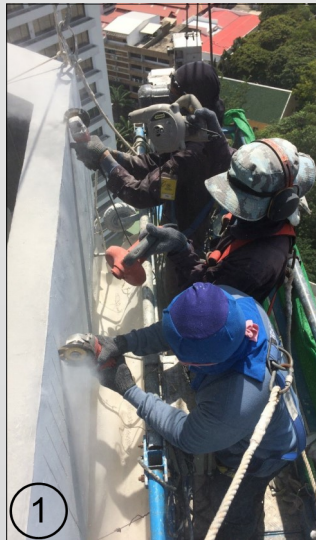
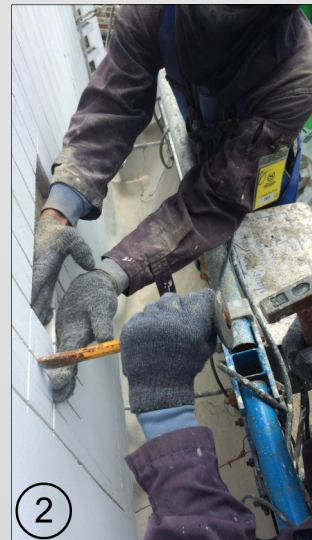
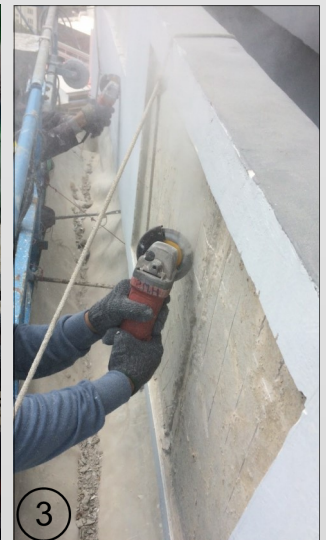
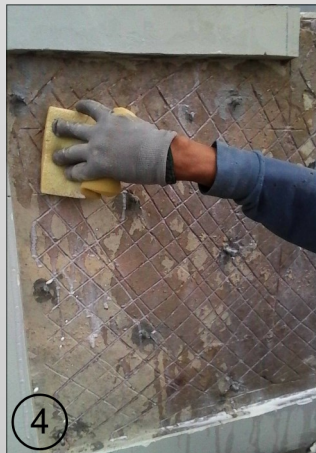
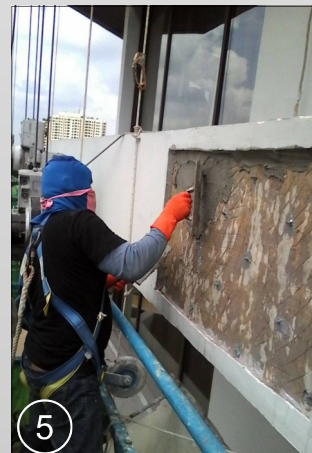
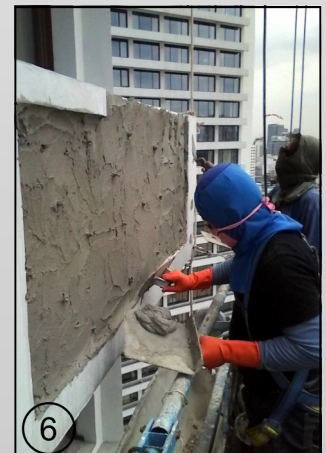
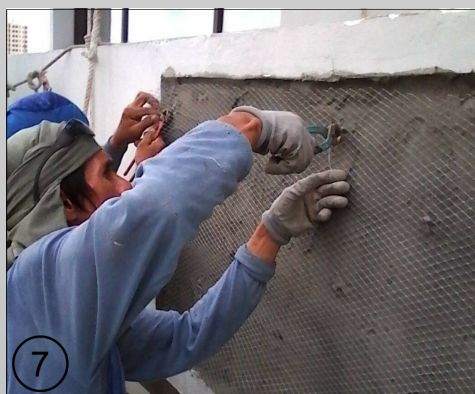
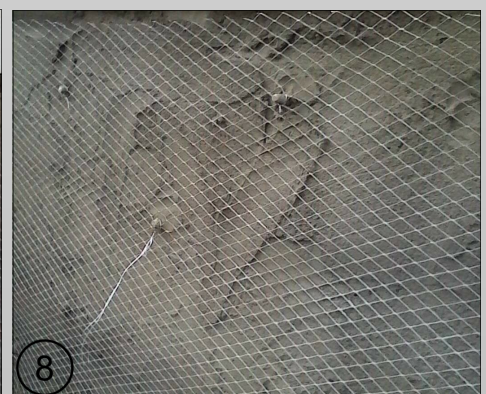
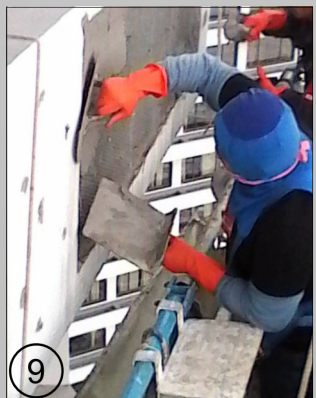
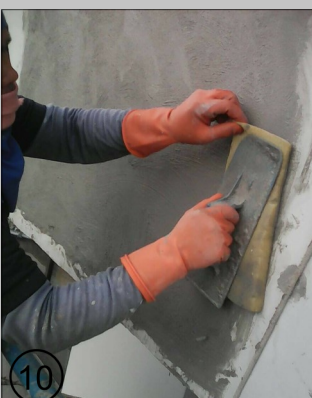
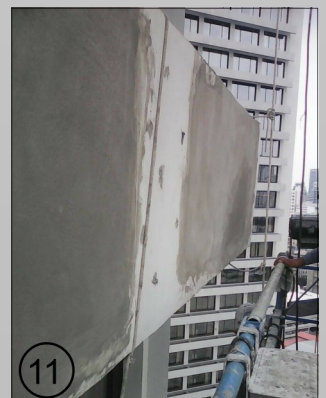
1. Saw cut demarcation of hollow area and grid cutting of patch.
2. Careful removal of render by hand.
3. Saw cutting “key” in base.
4. Installation of mesh fixings and surface preparation.
5. First coat re-render.
6. Completion of first coat.
7. Installation of expanded metal mesh.
8. Mesh completed.
9. Second coat render
10. Finishing
11. Completed patch repair

The majority of areas of debonded render discovered were repaired using a “render pinning” technique however in a cases where the render was particularly thick and at risk, traditional repairs were carried out.
