Shotcrete Repair to Headstock Beams - Siam Seaport, Au Udom, Thailand.

PROJECT DETAILS

Shotcrete Repairs to Headstock Beams
Siam Seaport Co., Ltd.
Phase one of a four year project to carry out concrete repairs to 96 No headstock beams, including the fabrication of two 94m long, 160 ton, mobile headstock isolation truss bridges, and the placement of 1500 tons of HPP fiber reinforced shotcrete

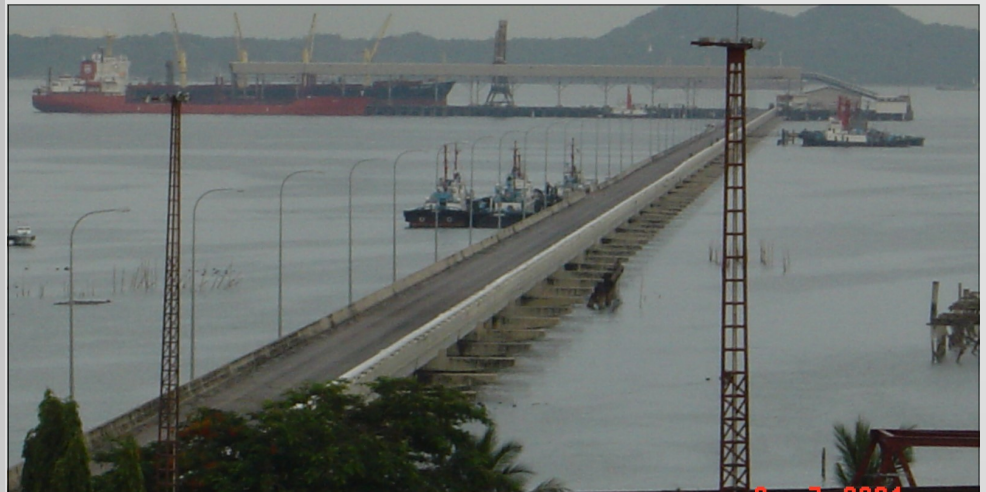
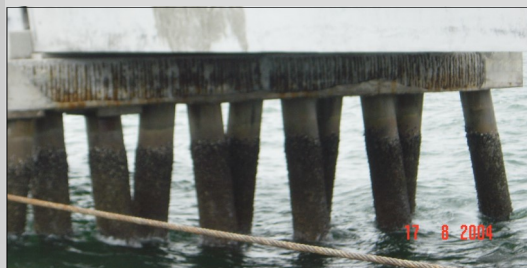
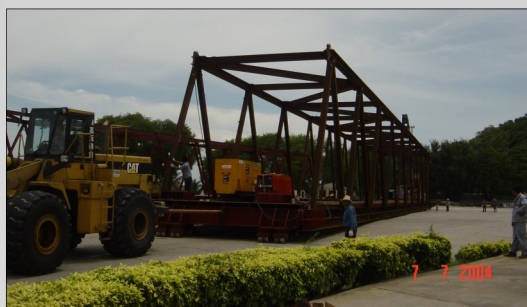
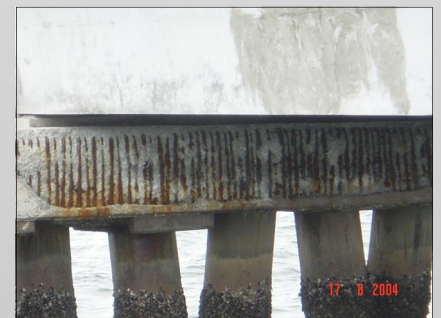
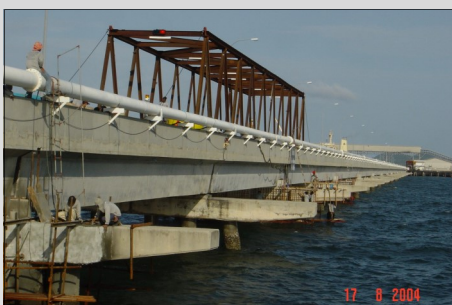
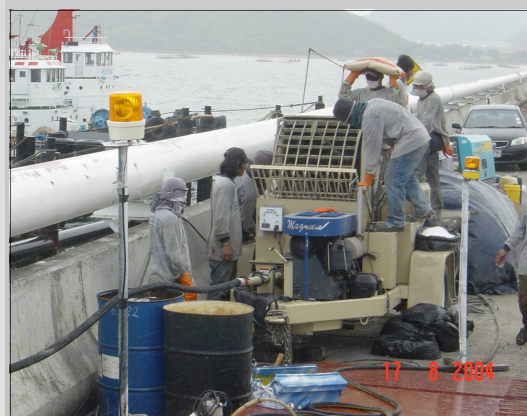
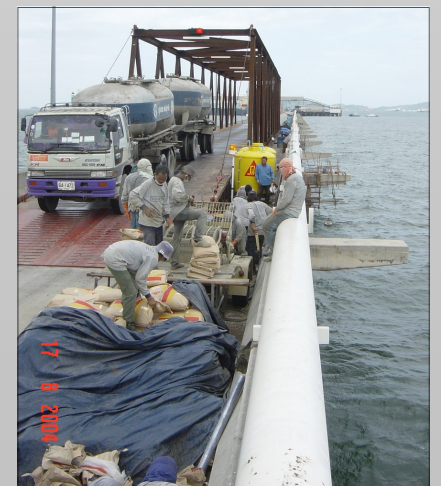
The primary mode of deterioration was considered to be "crack propagation due to torsion fatigue of the cover concrete" requiring that the headstock repair material incorporate 1% by volume High Performance Polypropylene Fibers of a length not less than 50 mm.

Hammersmith sourced and imported the required fiber and, based on the small volume of material to be "shot" at each repair location, proposed the use of a small volume wet shotcrete process machine.

An Allentown POWERCRETER Magnum was subsequently imported for this repair project allowing on site batching of the HPP fibers and repair mortar.
