Hypalon / PVC Joint Tape System – Top-side of Leaking Joint

Hypalon / PVC Joint Tape System – Underside of Leaking Joint

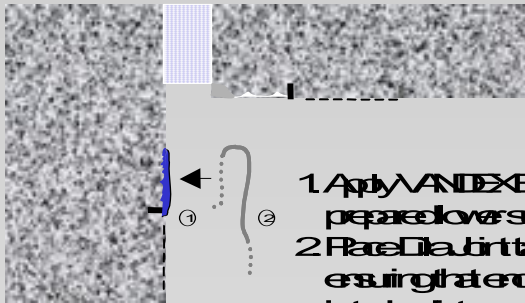
- 1 Apply VANDEX BB75E prepared surface
- 2 Place Dila Joint tape ensuring that end of "mesh" is tucked into saw cut
- 3 Allow cure

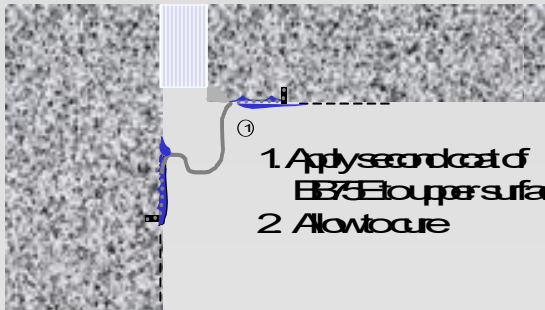
1. Apply second coat of BB75E to upper surface
2. Allow cure
